Argyle Chapel, Swansea

This large 18th Century chapel had fallen into disrepair. To compound its problems, there was a major fire part way through a conversion project to turn the chapel into apartments.

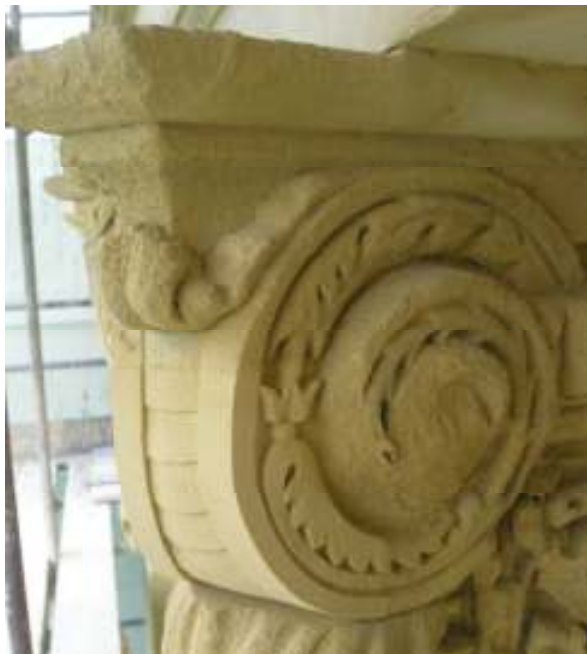
A cleaned and consolidated capital, showing a newly pieced in section of Bath stone, carved so to be invisible from ground level but evident when seen at close quarters.

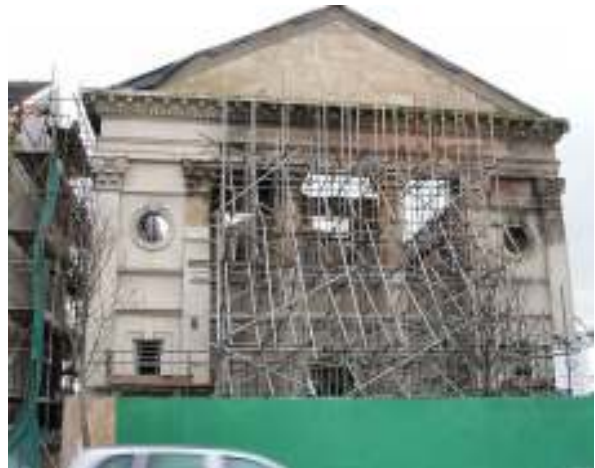
Only operational trials would establish a range of cleaning techniques required to remove the mixture of historic soot blackening, unburnt paint, burnt paint and smoke blackened Bath stone.

The key to success on this project was gaining the trust of architect, client, quantity surveyor and main contractor—none of whom had any experience of this type of conservation work. This allowed the methodology and approach to vary until the most appropriate systems were found. A combination of Jos & Doff cleaning were found to be effective.

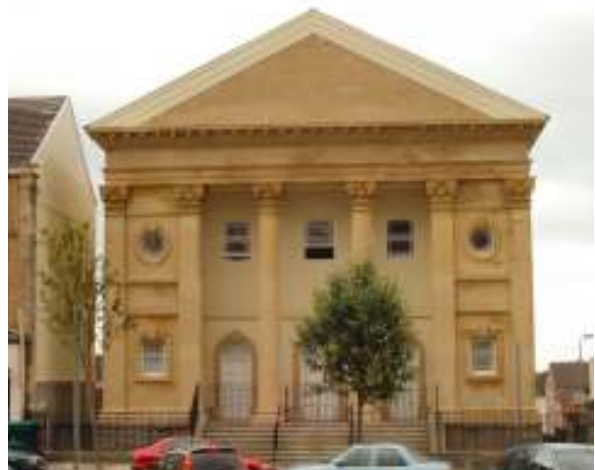
The chapel following completion—on time and on budget.
