Twyford Chapel, St Michael's Church, Derbyshire

Rob Thomson, September 2006

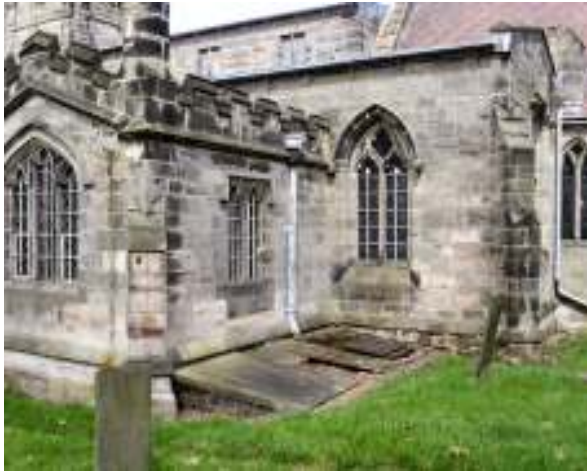
An external view of the chapel, the troublesome shallow pitch lead roof can just be seen

Discussions with parishioners identified that the lead roof above the ceiling had been replaced 20 years ago.

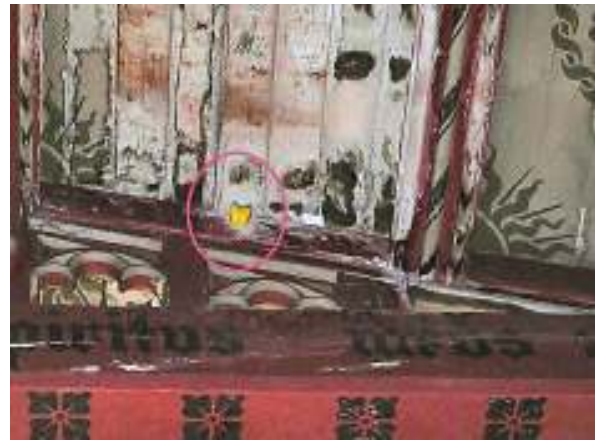
Data loggers were installed inside and outside the church to establish a pattern to the humidity and temperature within the church—was condensation a problem?

A Victorian decorative paint scheme was added to the timber ceiling of this medieval chapel but had suffered over recent years. The paint was flaking everywhere and much of the paint on the ceiling appeared to have been damaged by water ingress.

The poor condition of the decorative scheme—a data logger (circled) is installed at ceiling level.
