## Stoney Littleton Long Barrow, Somerset

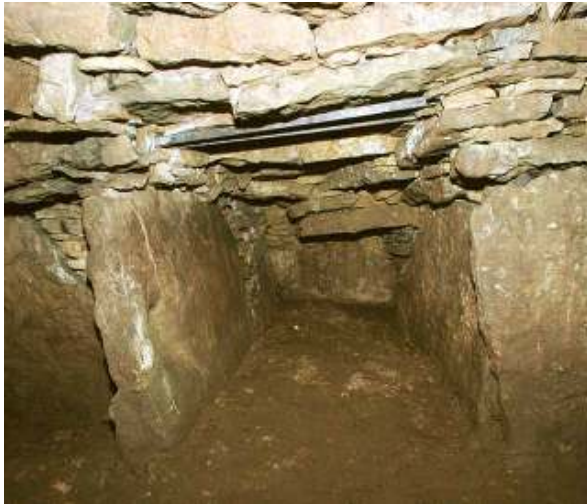
View into a side chamber, showing bronze reinforcement bars fitted at vulnerable points.

After discussion with a structural engineer from English Heritage we chose to replace these stones with new and to reinforce the vulnerable areas with bronze bars. Bronze was chosen over stainless steel as it was equally stable and less visually intrusive than stainless steel.
