## Stoney Littleton Long Barrow, Somerset

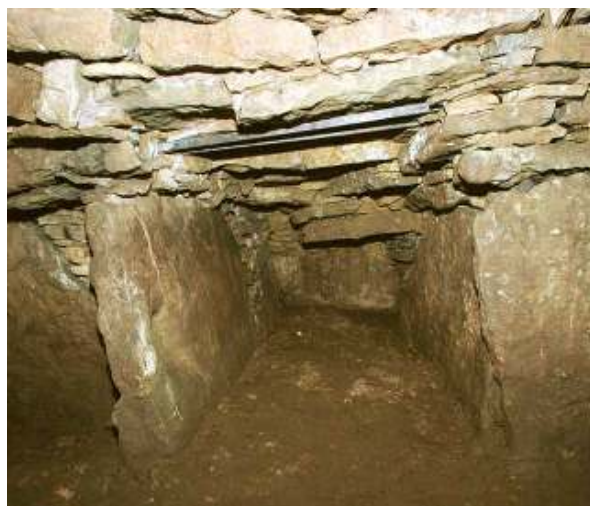
View into a side chamber, showing bronze reinforcement bars fitted at vulnerable points.

After discussion with a structural engineer from English Heritage we chose to replace these stones with new and to reinforce the vulnerable areas with bronze bars. Bronze was chosen over stainless steel as it was equally stable and less visually intrusive than stainless steel.

Failed stones were replaced before the monument was rebuilt, stone by stone, by the conservators before the monument was profiled back to its original shape with new soil and an ecologically appropriate turf.
