The Roman Baths Museum & Monument

Assisting with priorities and specifications for the conservation of the stone and plasterwork at this monument—the most complete Roman baths complex in northern Europe is a project I have been involved with for many years, previously with Cliveden Conservation Workshop. The following is a selection of some past and present projects.

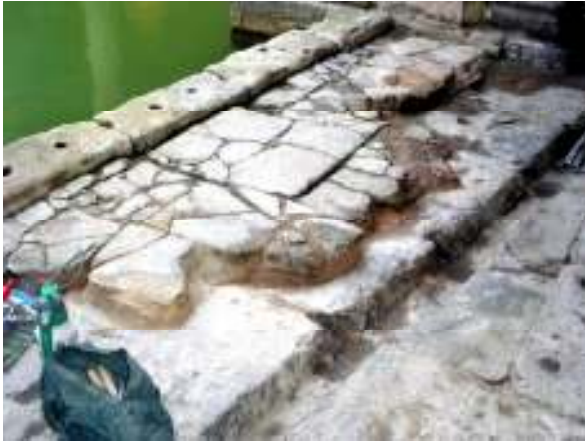
Identifying and specifying repairs to secondary limestone paving in the Great Bath.

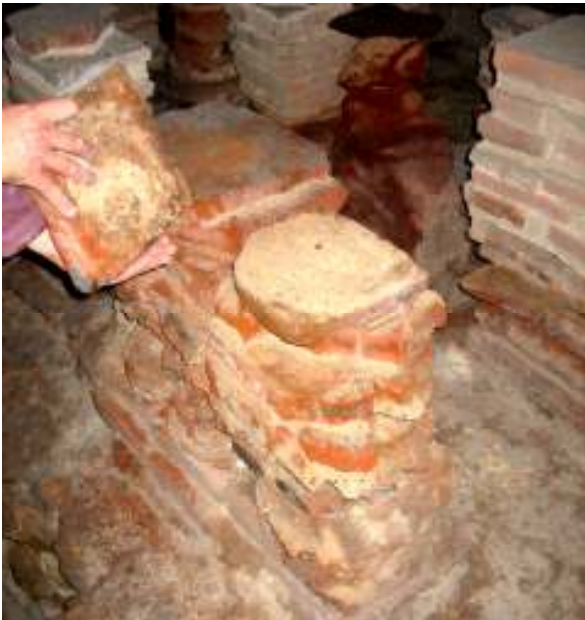
Identifying and specifying rebuilding and rebedding of terracotta pilae stacks, often with the addition of damp proof membranes to slow decay.

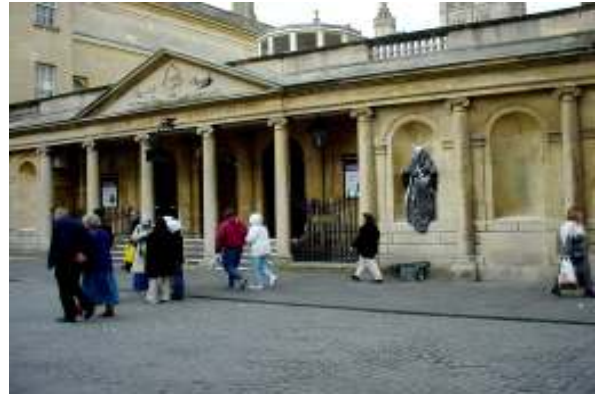
Stone survey of the external elevations of the Baths complex.

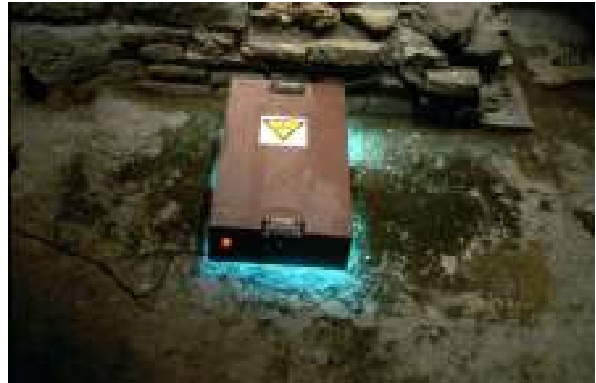
An interesting personal research project is the development of a light-box fitted with ultraviolet light bulbs. Initial results, following trials at the Baths, suggest that this system acts as an efficient non-contact and chemical free method for controlling organic growth.
